ARCHITECTURAL HERITAGE AND CONSERVATION PRACTICES

Architectural Heritage and Conservation Practices

Assoc. Prof. Dr. H. Hale Kozlu

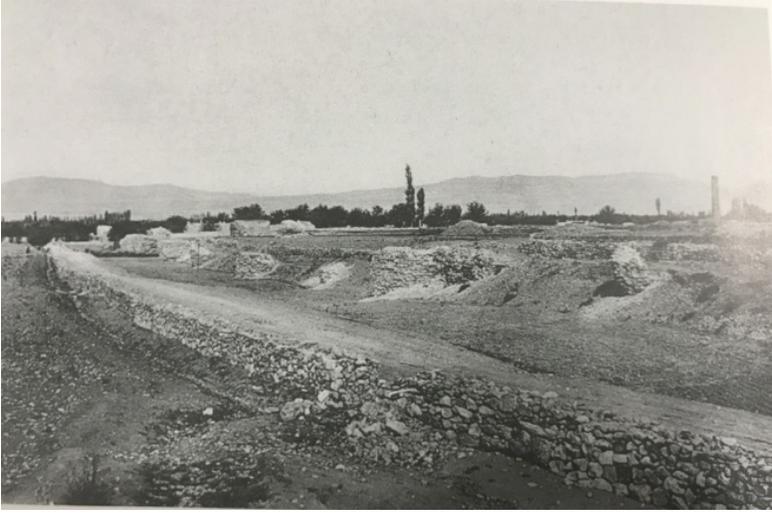
Figure 3. General condition of the city walls in 1932 (Gabriel, 2022: 400)

The outer walls of the castle mentioned by the travelers have a trapezoidal plan close to a rectangle. Both for the terrain conditions and to strengthen the defense, the eastern walls were built by the stream and narrowed towards the north in accordance with the shape of the Derme stream (Eskici, 2013: 28).

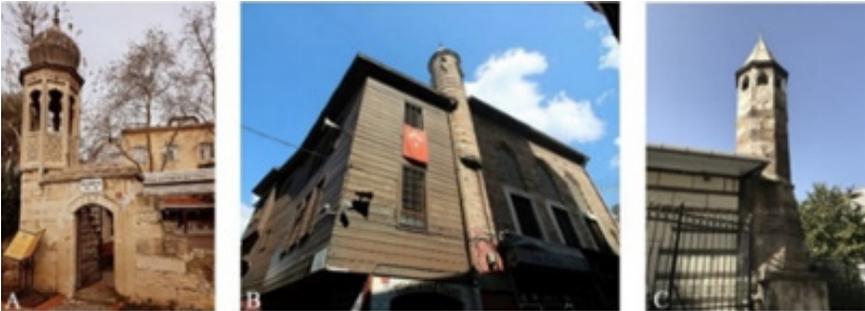
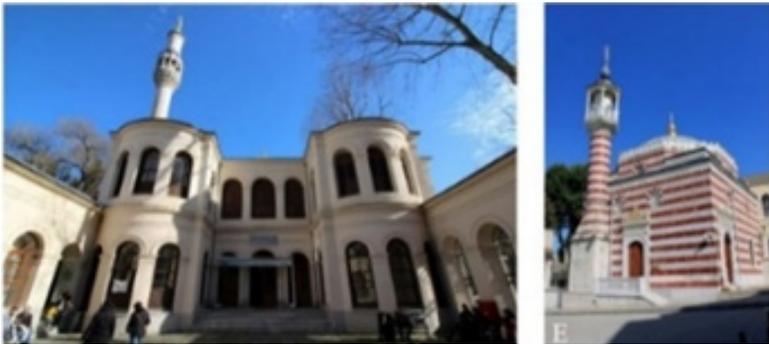
Figure 1. A. Sokullu Mehmet Pasha Mosque (Kıran, 2021)

B. Timurtaş Masjid (Dilekoğlu, 2021)

C. Derviş Ali Masjid (Köroğlu, 2020)

D. Küçük Mecidiye Mosque (Dileoğlu, 2019)

E. Nallı Masjid (Dilekoğlu, 2017)

The most striking of these minarets is the Sokullu Mehmet Pasha Mosque, built in the 16th century by Mimar Sinan, whose railing and arches form the serefe, which is reached by a stone staircase from the outside. In the following years, examples of minarets placed in the form of a bay window were found on the side wall, as in Tahtakale Timurtaş Masjid. In the 17th and 18th centuries, there is an example of Derviş Ali Mosque with a polygonal body on a square pedestal and an ornamented railing forming the serefe. An example of this type of minaret in the 19th century is the Babıali (Nallı) Mosque, which has a serefe with a protruding cover on a thin body. In Küçük Mecidiye Mosque, it is an example from the later period when the serefe was not covered (Eyice, 1953;254-257).

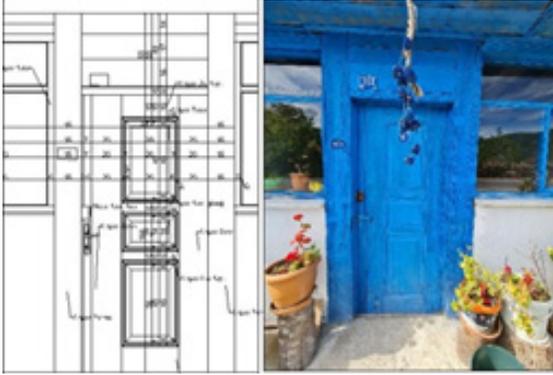
Figure 15. Zekiye Keskin House shop entrance door

Shop doors are combined with shuttered windows to form a system. Architectural richness is increased with different door-window combinations. For example; on the façade of Selamettin Yılmaz house, there is a combination system consisting of window-door-door-window respectively. On the shop façade of Şenel Akıllı House, the system formed by the combination of door-window-door-window-window-door-window stands out. In Vehbi Kahveci, Zekiye Keskin and Vahdettin Erdem houses, the shop facade is formed with a window-door-window combination (Figure 15).

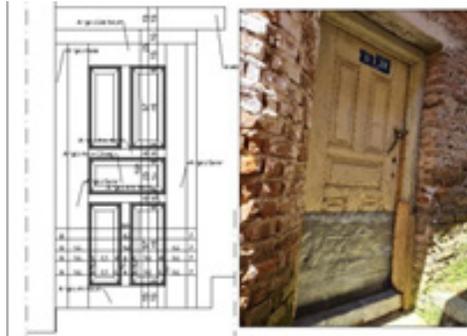
Figure 16. Vehbi Kahveci House side façade residential entrance door

Apart from the aforementioned decorated doors, the other doors were fixed with wooden veneers perpendicular to the floor complementing the door opening in their front views, and with horizontal wooden records in their rear views and fixed with the help of scratches. The artistic quality of the doors added to the buildings emphasises the importance of the space (Figure 16, Figure 17).

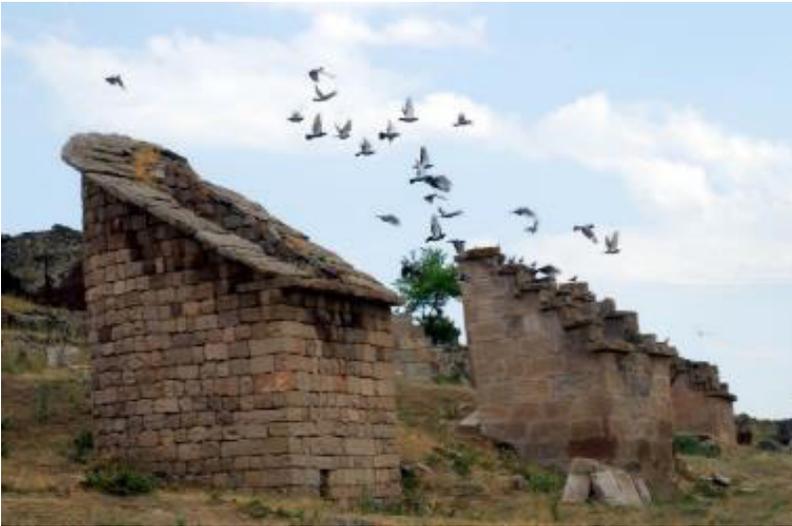
Figure 1. General view of dovecote (Büyükmihçı, 2006)

used during their construction, portray valuable examples in terms of obtaining products that contribute to organic agriculture and ecological balance, as well as their architectural values. (Figure 1).

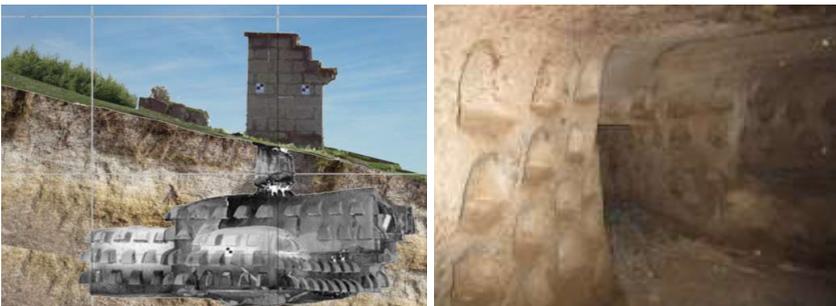
Figure 2. Bushing and underground nest of the dovecote (Albayrak, 2019)

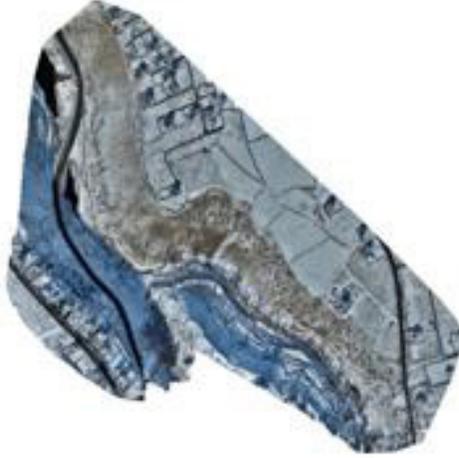
Figure 4. Orthomosaic sparse Digital Surface Model (DSM) before densification and top view of the initial image position

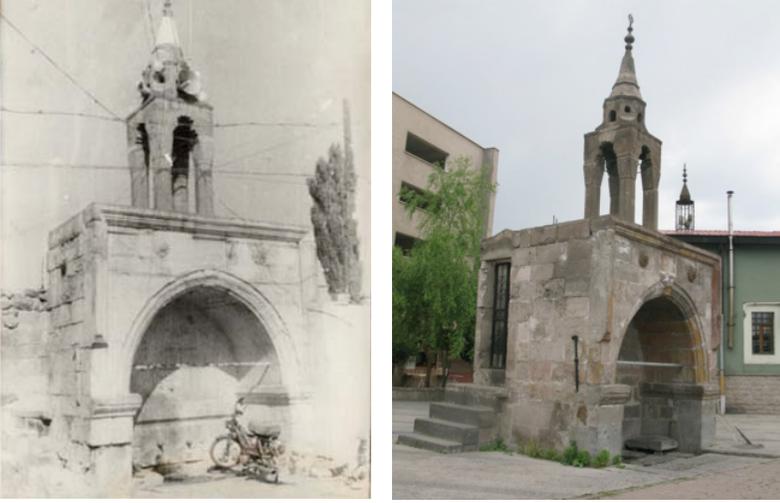
Figures 3, 4. Seyitgazi Fountain and Minaret in its old place (K.K.V.K.B.K. Archives) and at the point where it was moved

Approximately 200 fountains, which were built on streets, squares and corners during the Seljuk, Principalities, Ottoman and Republican periods in the city centre of Kayseri, have survived to the present day (Yörükoğlu, 1987, p. 7). In the interviews, it was determined that 32 fountains in traditional neighbourhoods took place in the memories for at least 2 generations in the transfer of cultural memory, and were transferred to the new generations through oral narratives in this period. Of these buildings mentioned in oral history studies; while “Çatalpınarı, Hacımemiş Fountain, Hacışirin Fountain, Mıhlım Fountain, Sıtmapınarı Fountain, Büyük Fountain, Deliklitaş Fountain, Göllü Fountain, Çifteönü Fountain, Matra Fountain, Nazmi Toker Fountain, Kavaklı Fountain, Çatal Fountain, Çakaloz Fountain” are present and in place today, “Hasanbey Fountain, Kalencilerhane Fountain, Mahrem Fountain, Eskibahçe Fountain, Hamzaoğlu Fountain, Çakalkız Fountain, Akmazsokak Fountain, Havuççular Fountain, Hacıkılıç Fountain, Hunat Fountain, Cennet Fountain, İnönü Primary School Fountain, the fountain on the wall of Ahmetpaşa Primary School, Katroğlu Fountain, Setenönü Fountain” have been demolished now. “Sahabiye Fountain (Figure 2), Seyitgazi Fountain (Figures 3, 4) and Gülük Fountain (Figure 5)” were moved from their original places.

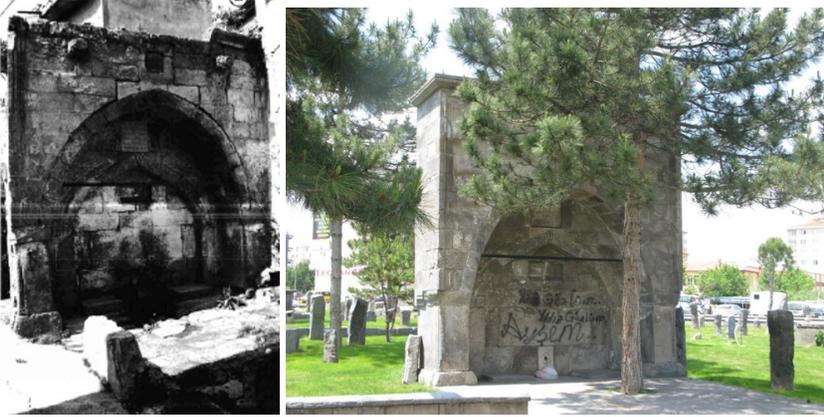
Figures 7, 8. Hacı Mehmet (Kaptan Paşa) Fountain in its old place (K.K.V.K.B.K. Archives) and at the point where it was moved

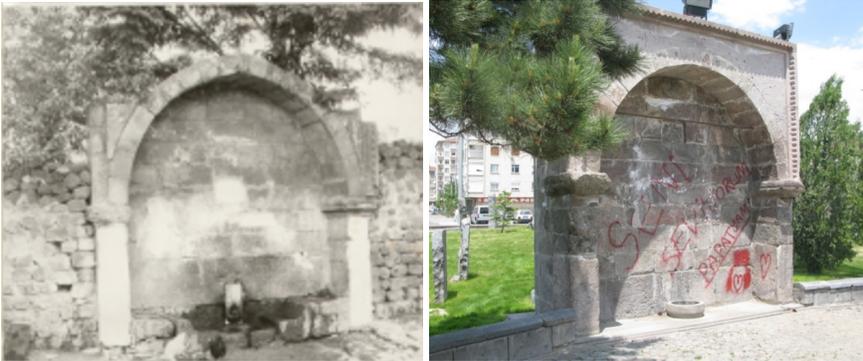
Figures 9, 10. Hüsrem Fountain in its old place (K.K.V.K.B.K. Archives) and at the point where it was moved

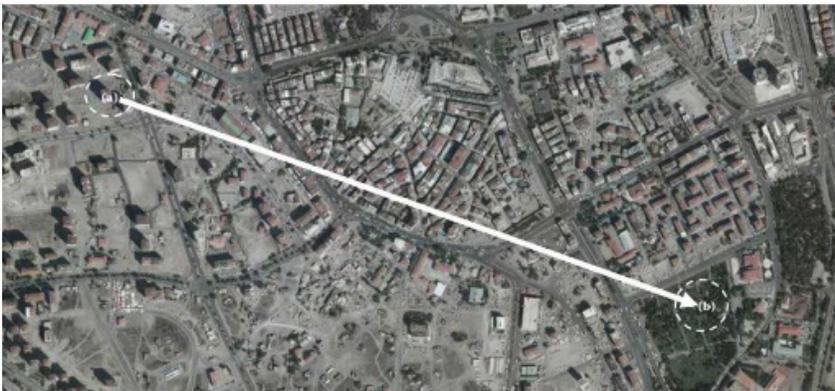
Figure 11. The original location of the Hacı Mehmet (Kaptan Paşa) Fountain and the cemetery where it was moved

When the reasons for moving the fountains are examined, it is understood that the majority of them were removed and transferred to another point due to zoning problems. The reasons for the relocation of these fountains, which were moved with the decision of the Conservation Board, are explained in the decisions of the Kayseri Cultural Heritage Preservation Regional Board. According to these documents in the archive, some of these fountains were completely removed from their location and moved to an area within the Seyyid Burhaneddin Cemetery. For example, Hacı Mehmet (Kaptan Paşa) Fountain (Figures 7, 8), built in Bozatlı Paşa Neighbourhood Adak Street in 1807, was moved due to the fact that it was about to be demolished, it was dangerous, and the surrounding construction was formed without considering the fountain, making it difficult to preserve the fountain in place. The Hüsrem Fountain (Figures 9, 10), built in the 19th century at the intersection of Kaya and Durak Streets in Lala Paşa Neighbourhood, was moved to Seyyid Burhaneddin Cemetery in 2003, as it remained in the median of the 40-meter road in the zoning plan (Figures 11,12).

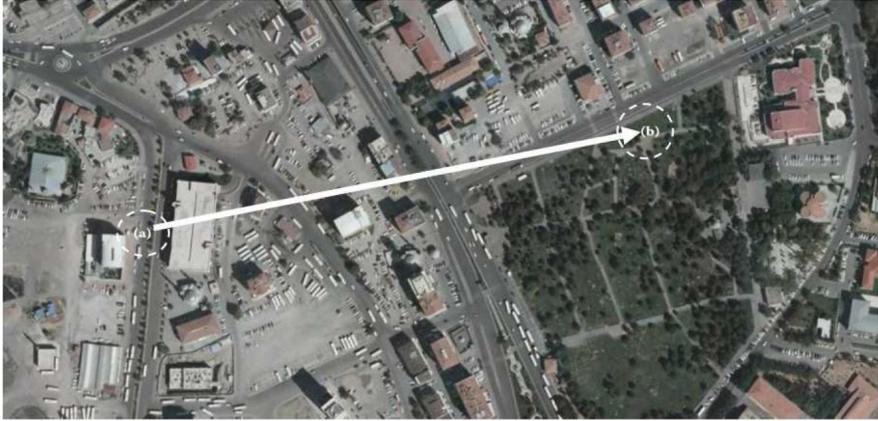
Figure 12. The original location of the Hüsrem Fountain and the cemetery where it was moved

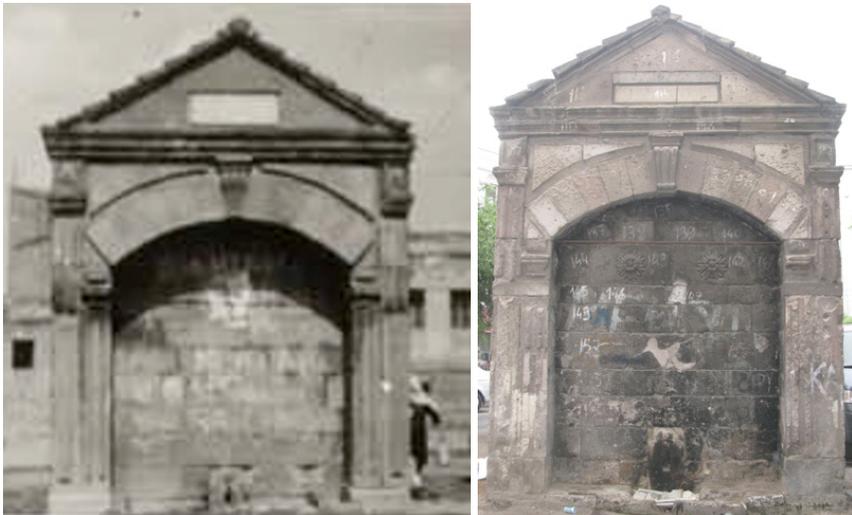
Figures 13, 14. Sivas Street Fountain in its old place (K.K.V.K.B.K. Archives) and at the point where it was moved

It is seen that other fountains have been moved to the vicinity of the street or avenue where they were originally located. For example, Sivas Street Fountain (Figures 13, 14), built on Sivas Street in the 19th century, was moved to the same street next to the Fevzioğlu Library (Figure 15), since it is located on the road route in the zoning plan. The Binbaşı Hacı Hayri Bey Fountain (Figures 16, 17) built in 1900/1923, next to the Hacıp Kümbeti at Zekai Bey Neighbourhood Fevzioğlu Street, was moved to the park in the same neighbourhood (Figure 18) due to road widening works.

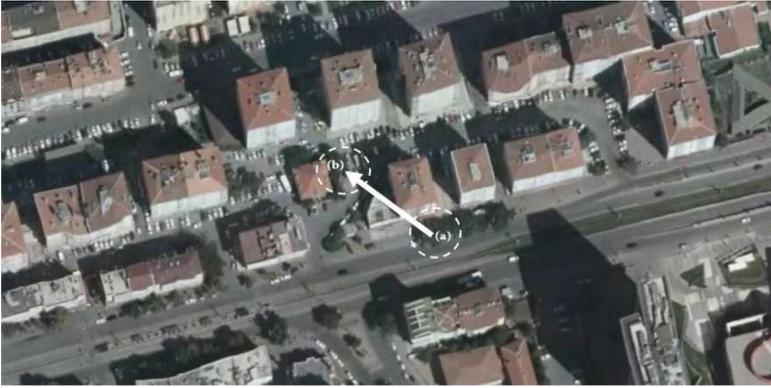
Figure 15. The original location of the Sivas Street Fountain and the point where it was moved

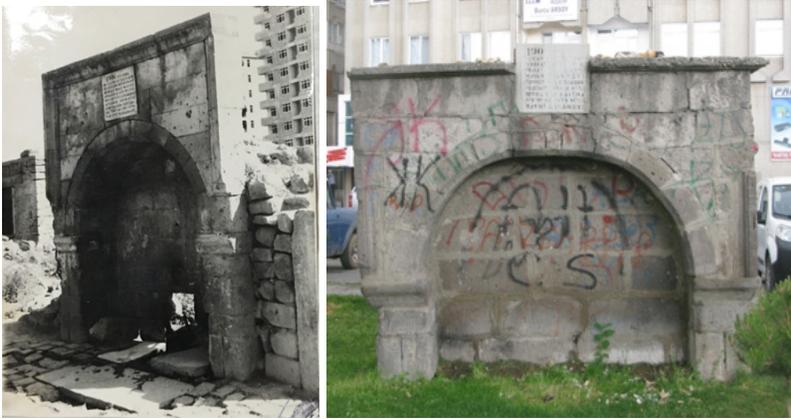
Figures 16, 17. Binbaşı Hacı Hayri Fountain in its old place (K.K.V.K.B.K. Archives) and at the point where it was moved

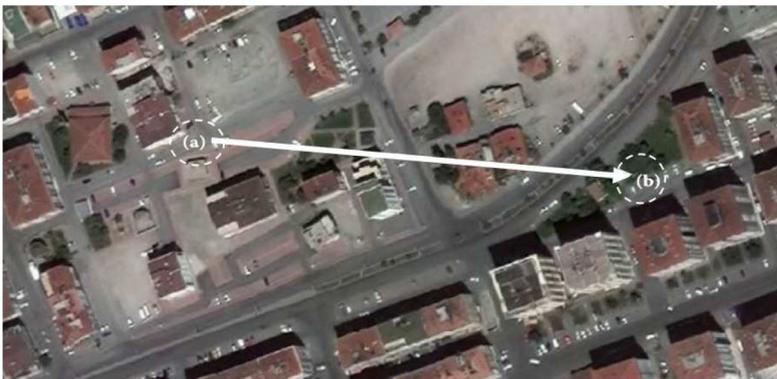
Figure 18. The original location of the Binbaşı Hacı Hayri Fountain and the point where it was moved

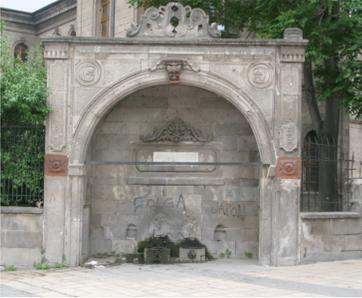
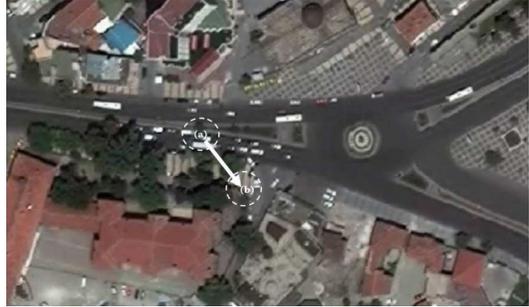
Figure 19. Lise (Şefika Hanım) Fountain, **Figure 20.** The original location of the Lise (Şefika Hanım) Fountain and the point where it was moved

Lise (Şefika Hanım) Fountain (Figure 19), built in 1921 on İnönü Street in Tosun district, was moved to the opposite side of the street due to road widening works (Figure 20). Şeyh İbrahim Tennuri Fountain (Figure 21), which was built in 1482 on Tennuri Street in Cumhuriyet district, was also moved to another point of the same street due to road widening works (Figure 22). The Talas Square Fountain (Figure 23), built in 1887 at the entrance of Ali Saib Pasa Street in the Kışıköy district, was taken across the same square in 1968 due to road widening works (Figure 24).

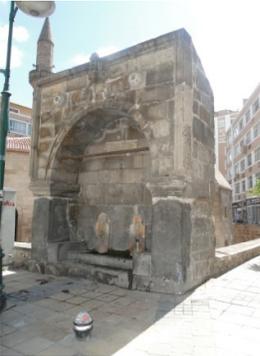
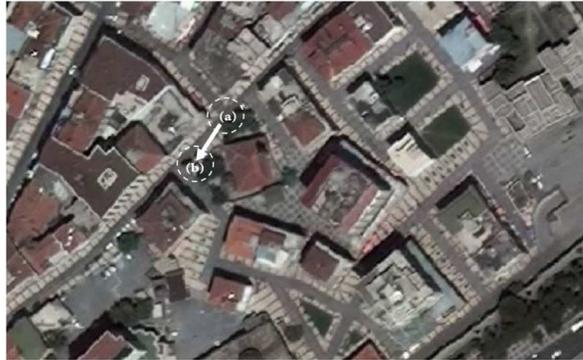
Figure 21. Şeyh Tennuri Fountain **Figure 22.** The original location of the Şeyh Tennuri Fountain and the point where it was moved

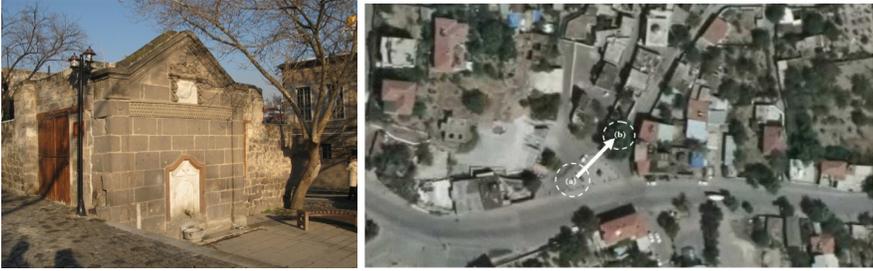
Figure 23. Talas Square Fountain, **Figure 24.** The original location of the Talas Square Fountain and the point where it was moved

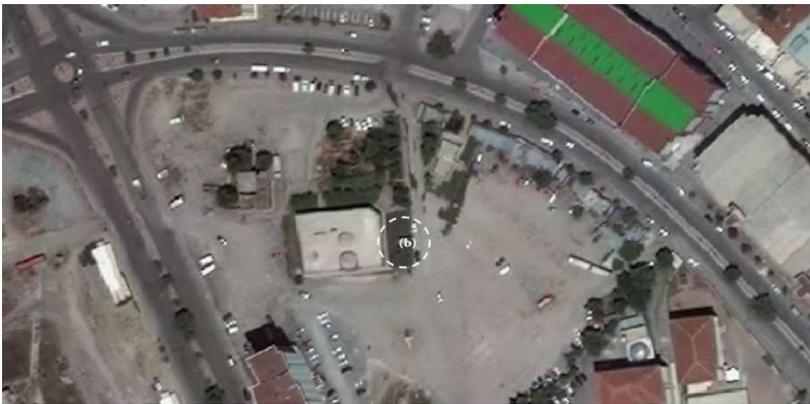
Figure 25. The original location of the Gülük Fountain and the point where it was moved

It is seen that among the moved fountains, the ones located next to a monumental building were moved to another point of the same building. The Gülük Fountain (Figure 5), which was built in the 18th century next to the Gülük Mosque, was taken into the courtyard of the Gülük Mosque for an unknown reason in 1905 (Figure 25), The Sahabiye Fountain (Figure 2), built in 1266 next to the masjid opposite the Sahabiye Madrasa, was moved to the east of the Sahabiye Madrasa at the beginning of the 20th century due to the square planning works (Figure 26), The Gevher Nesibe Fountain (Figure 27), built 5 m. south of the Gevher Nesibe Madrasa in 1868 (Denktaş, 2000), was moved to the southwest of the Gevher Nesibe Madrasa during the park planning works in 1988 (Figure 28). Seyitgazi Fountain and Minaret, built in 1904 (Denktaş, 2000) in the north of Seyitgazi Mosque (Figures 3, 4), on the other hand, since they are located on the newly opened Tacettin Boulevard route, they were taken into the garden of the mosque in 2001 (Figure 29).

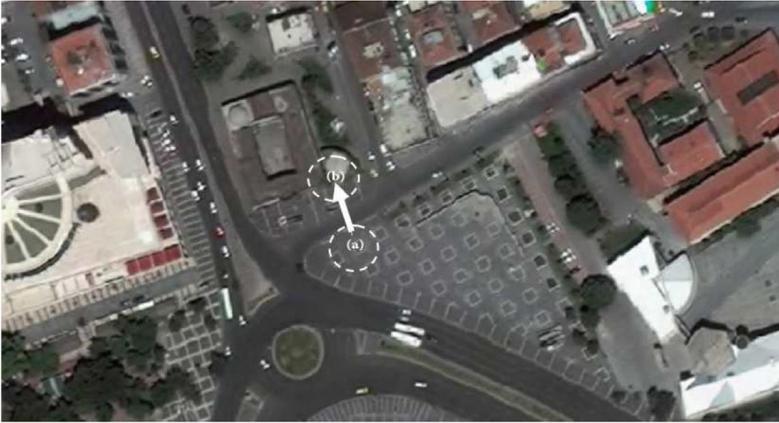
Figure 26. The original location of the Sahabiye Fountain and the point where it was moved

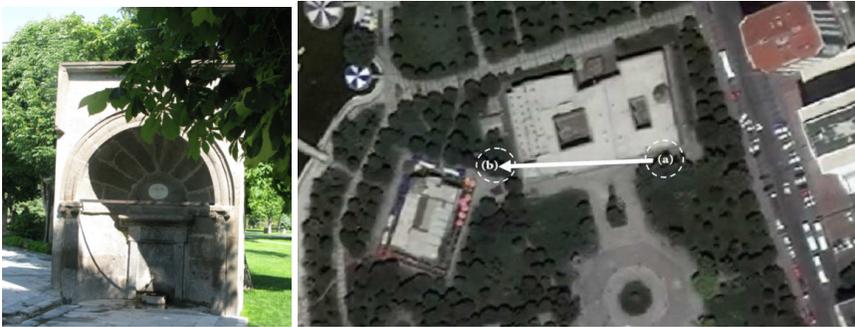
Figure 27. Gevher Nesibe Fountain, **Figure 28.** The original location of the Gevher Nesibe Fountain and the point where it was moved

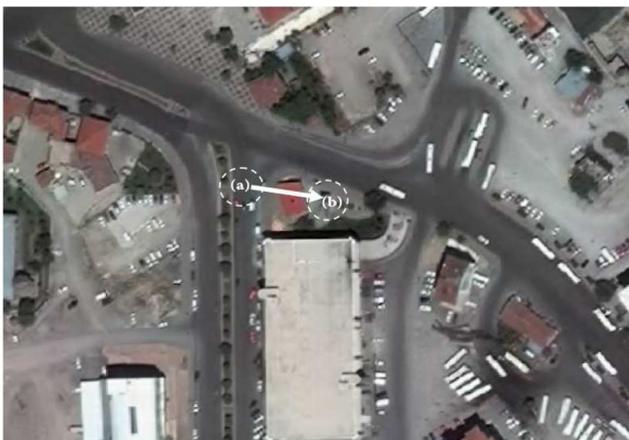
Figure 29. The original location of the Seyitgazi Fountain and Minaret and the point where they was moved
